**MULTI-MEDIA COMPLIANCE EVALUATION INSPECTION
U.S. ENVIRONMENTAL PROTECTION AGENCY
REGION III
OFFICE OF ENFORCEMENT, COMPLIANCE, & ENVIRONMENTAL JUSTICE**

**American Zinc Recycling Corporation
(formerly Horsehead Corporation)
900 Delaware Ave
Palmerton, Pennsylvania 18071**

Inspection Dates: 14-18 May 2018

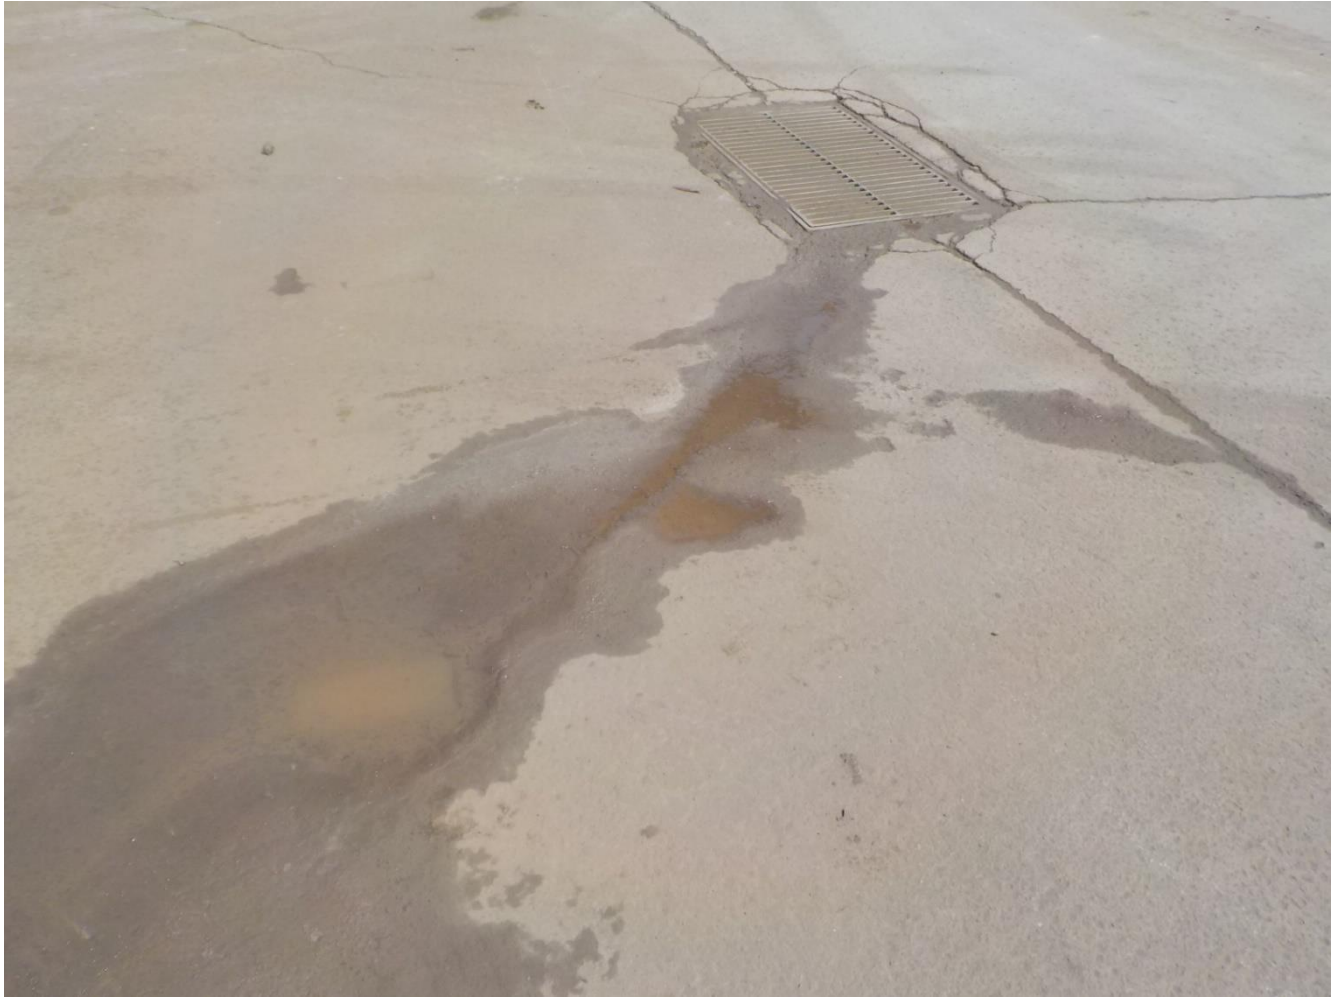
Photo 40. (DSCN0211) This photo is the third in a series of photos panning right to follow the path of the brown, cloudy water puddle shown in Photos 36 and 37. Note the brown cloudy water and water marks on the pavement lead to a storm water inlet, designated catch basin 15. See also Photo 41 for a closeup view of the inlet to catch basin 15.

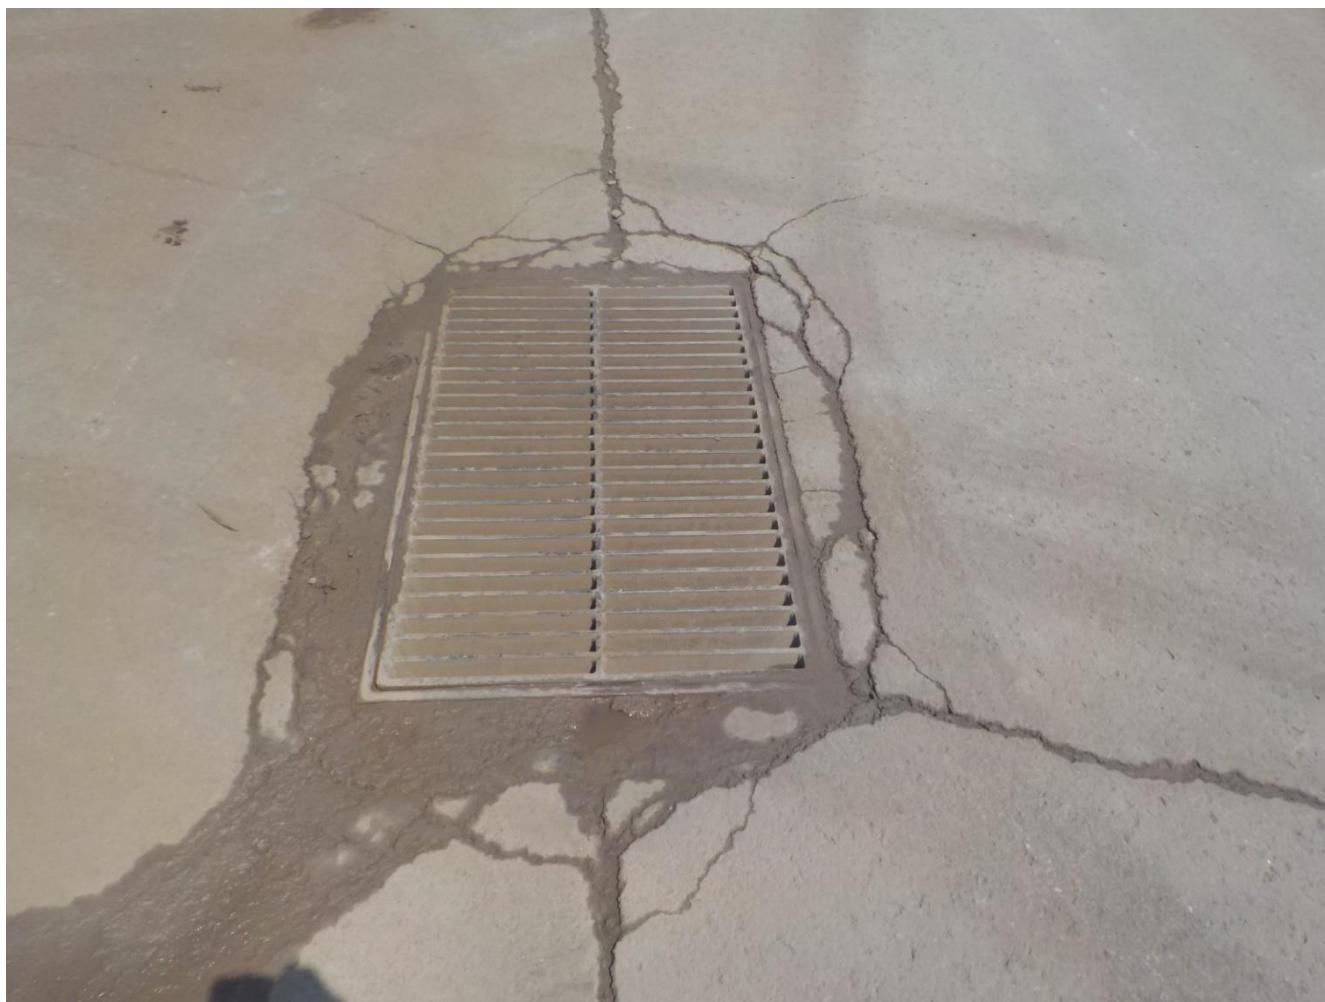
Photo 41. (DSCN0212) This photo, taken in the paved area between Buildings 608/624 and the Lime bunker, looks northward and shows a close-up view of catch basin 15. Note the deposits of wet, brown, fine-grained material around the edges of the inlet. See also Photo 42 for an interior view of the catch basin.

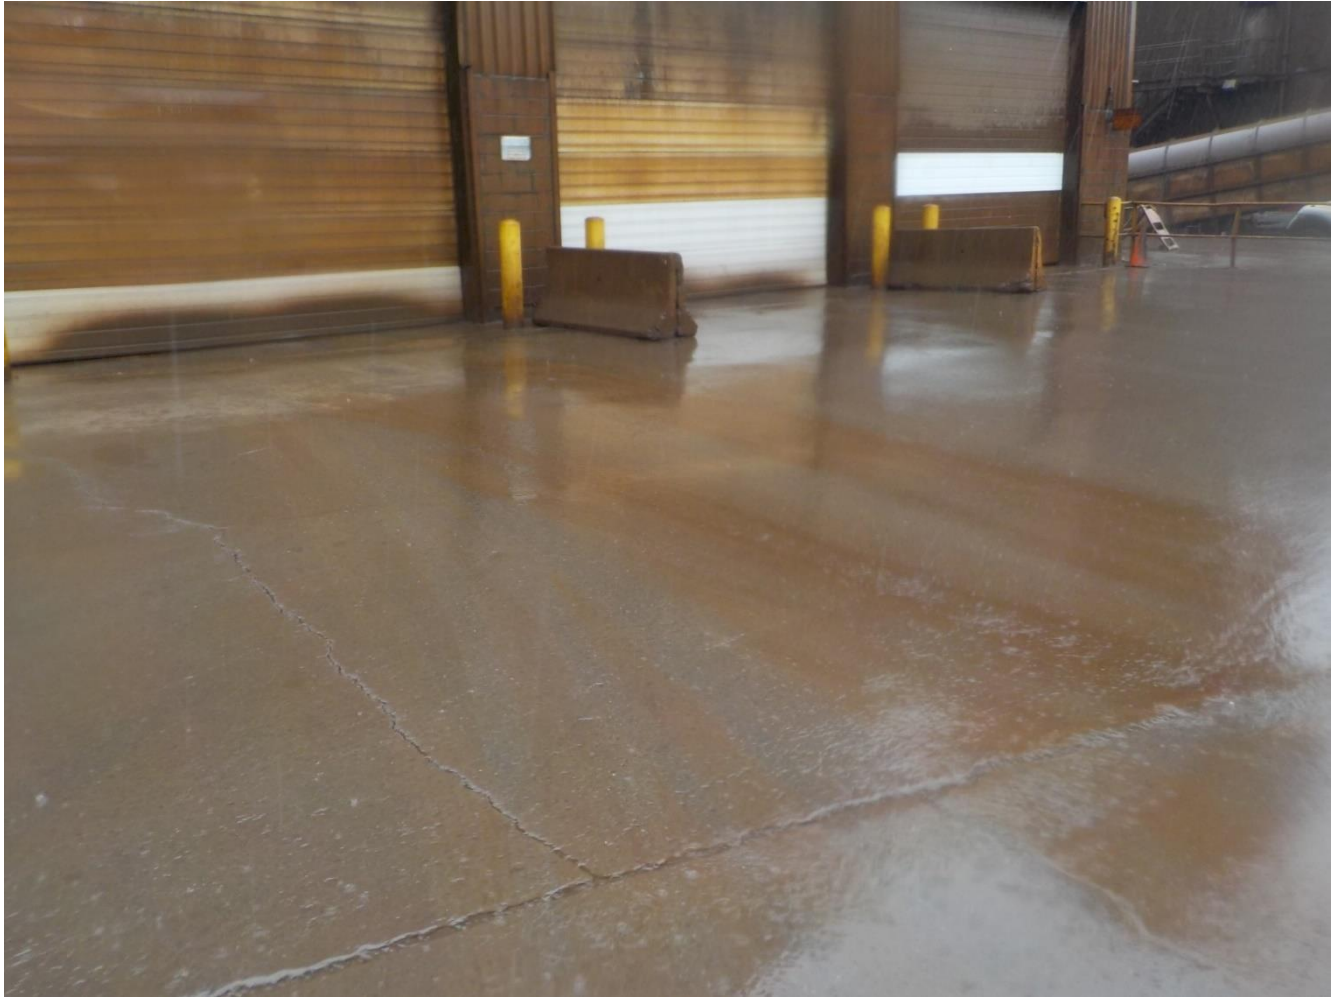
Photo 45. (DSCN0362) This photo, taken during rainy weather on 16 May, 2018, shows brown track-out marks originating from the exit doors of the truck wash bays (east side of Building 624). See also Photo 46.

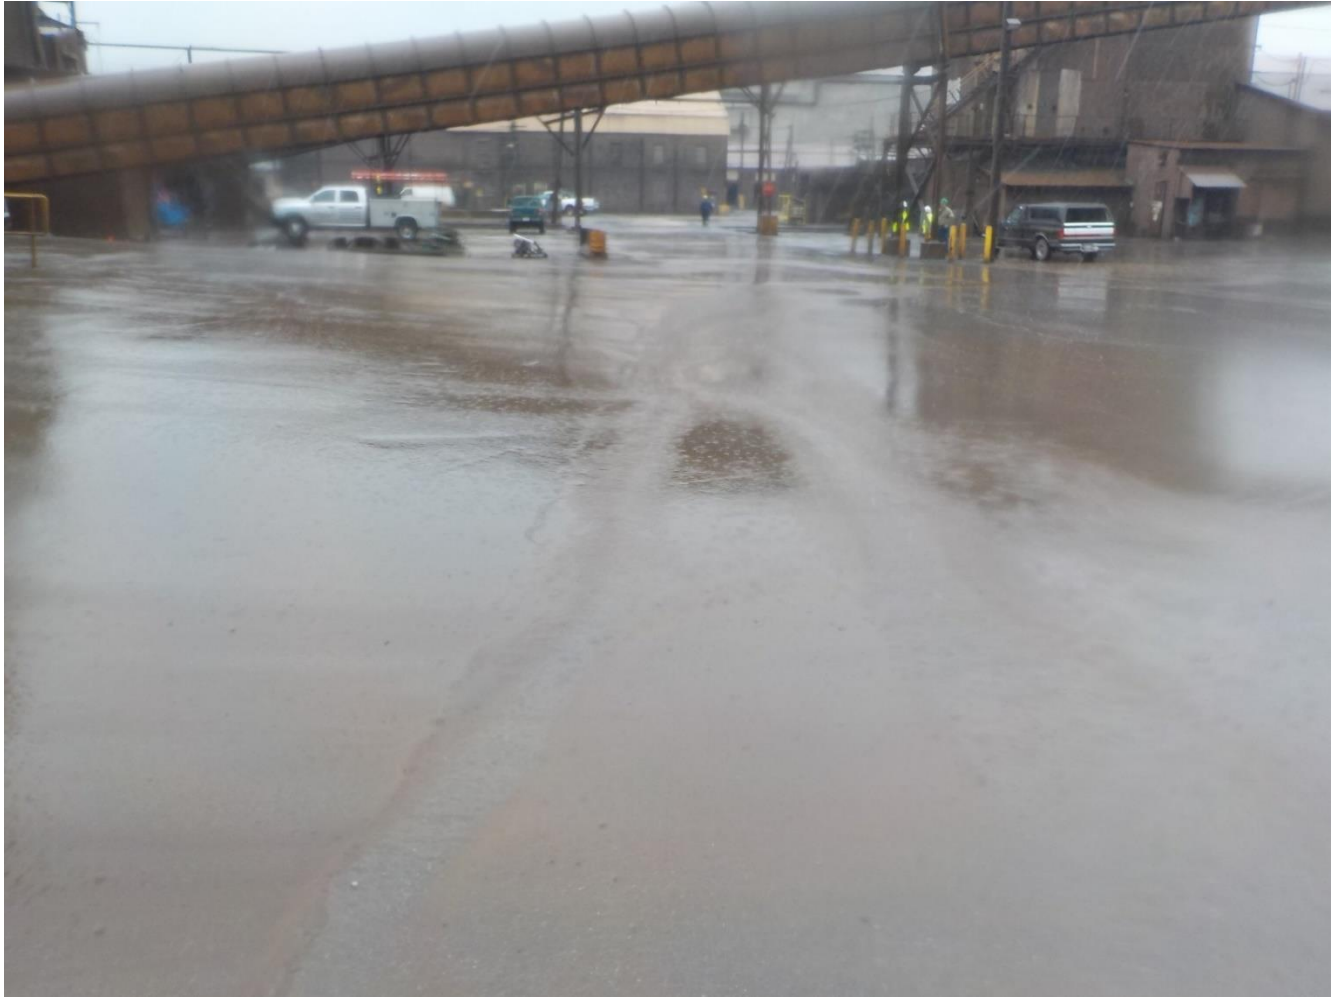
Photo 46. (DSCN0363) This photo, taken from just east of the truck wash bay exit doors, looks northward following the flow of storm water towards catch basins 15 and 18. Note also that the storm water from the large puddle in the vicinity of catch basin 9 shown in Photo 35, joins the flow of water visible here from the east (left side). See also Photo 47.

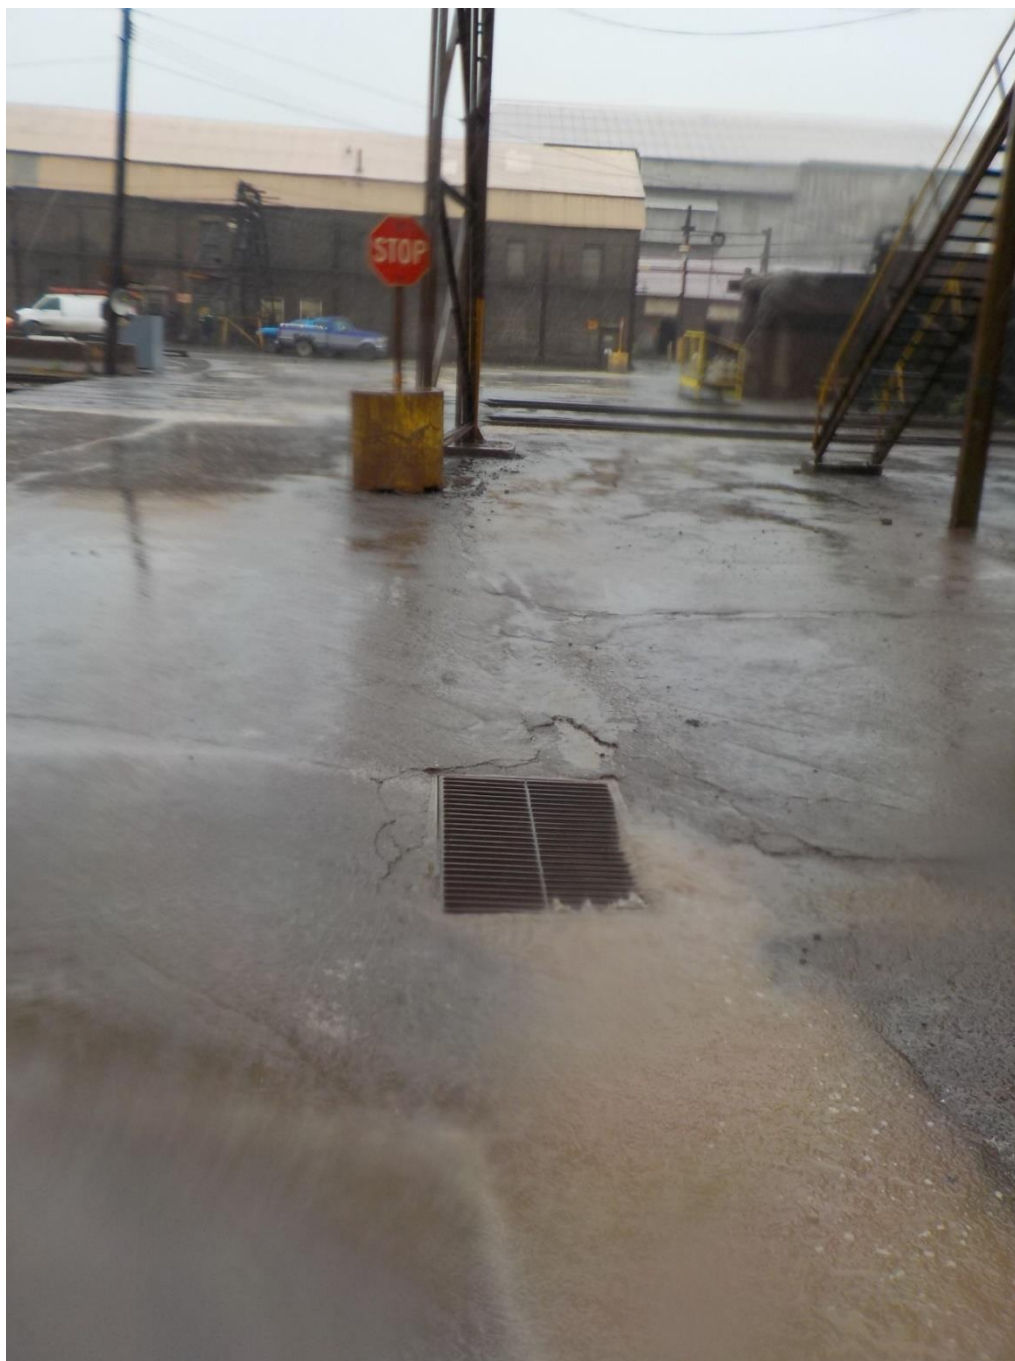
Photo 47. (DSCN0361) This photo, taken in the paved area between buildings 608/624 and the Lime bunker during rain on 16 May, 2018, looks northward towards catch basin 18. Note the flow of brown storm water into the inlet from the paved areas in between buildings 608/624 and the Lime Bunker. See also Photos 35, 45, and 46.

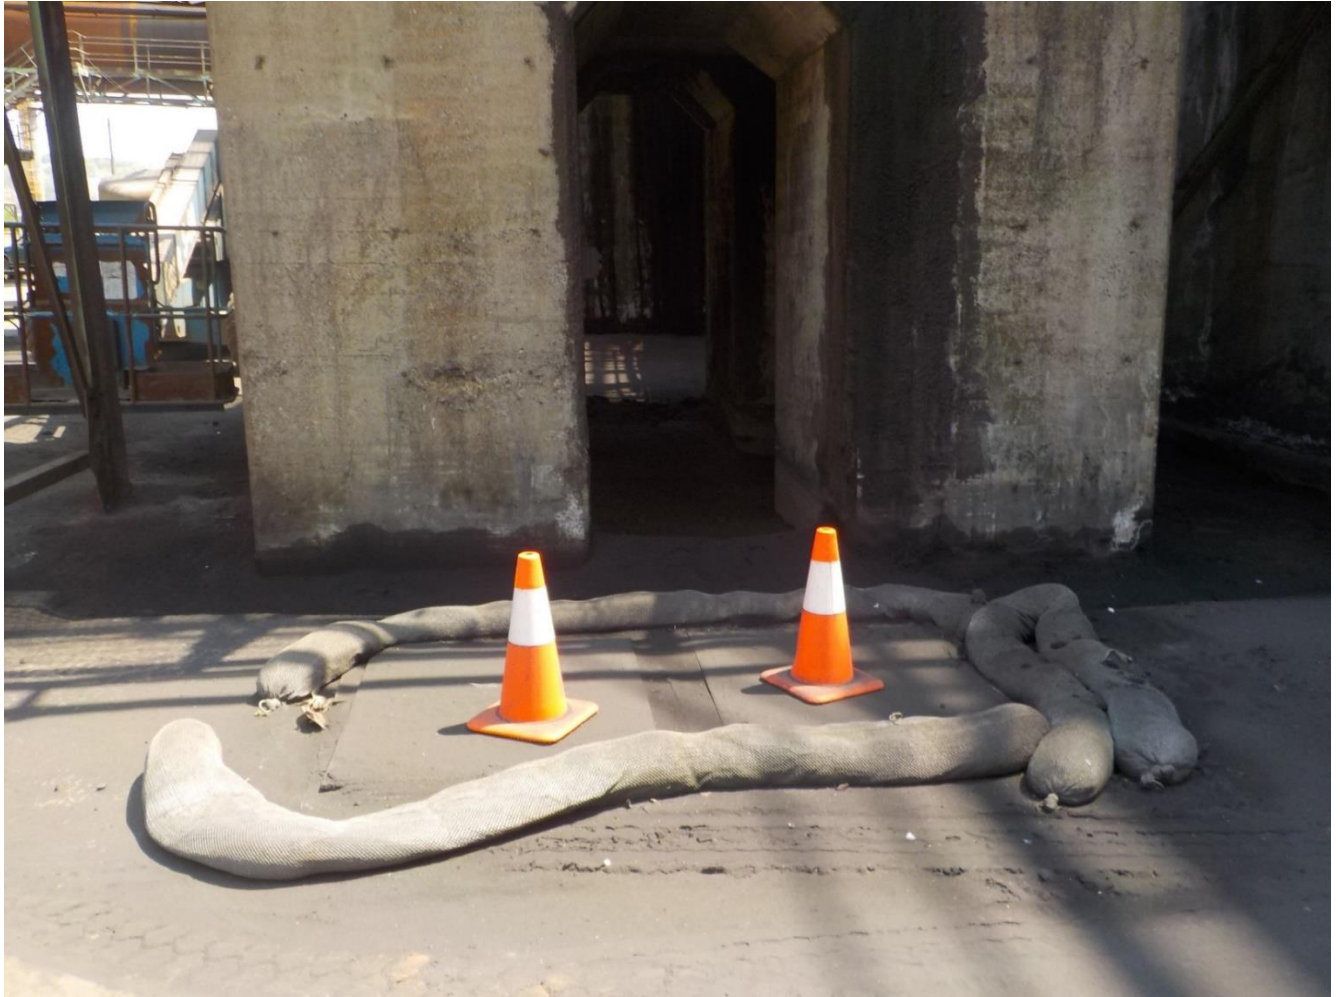
Photo 51. (DSCN0217) This photo, taken during dry weather on 15 May, 2018, shows another view of catch basin 5, immediately adjacent to the concrete support structures for the lower end of Kiln 2 (in the background). Note, the metal plates and absorbent socks on this inlet to the storm sewer system. According to Mr. Falko, this inlet was “closed” due to problems with IRM-contaminated water entering the system and requiring increased pH adjustment before discharge to outfall 004. See also Photo 52 for a comparison to wet weather conditions.

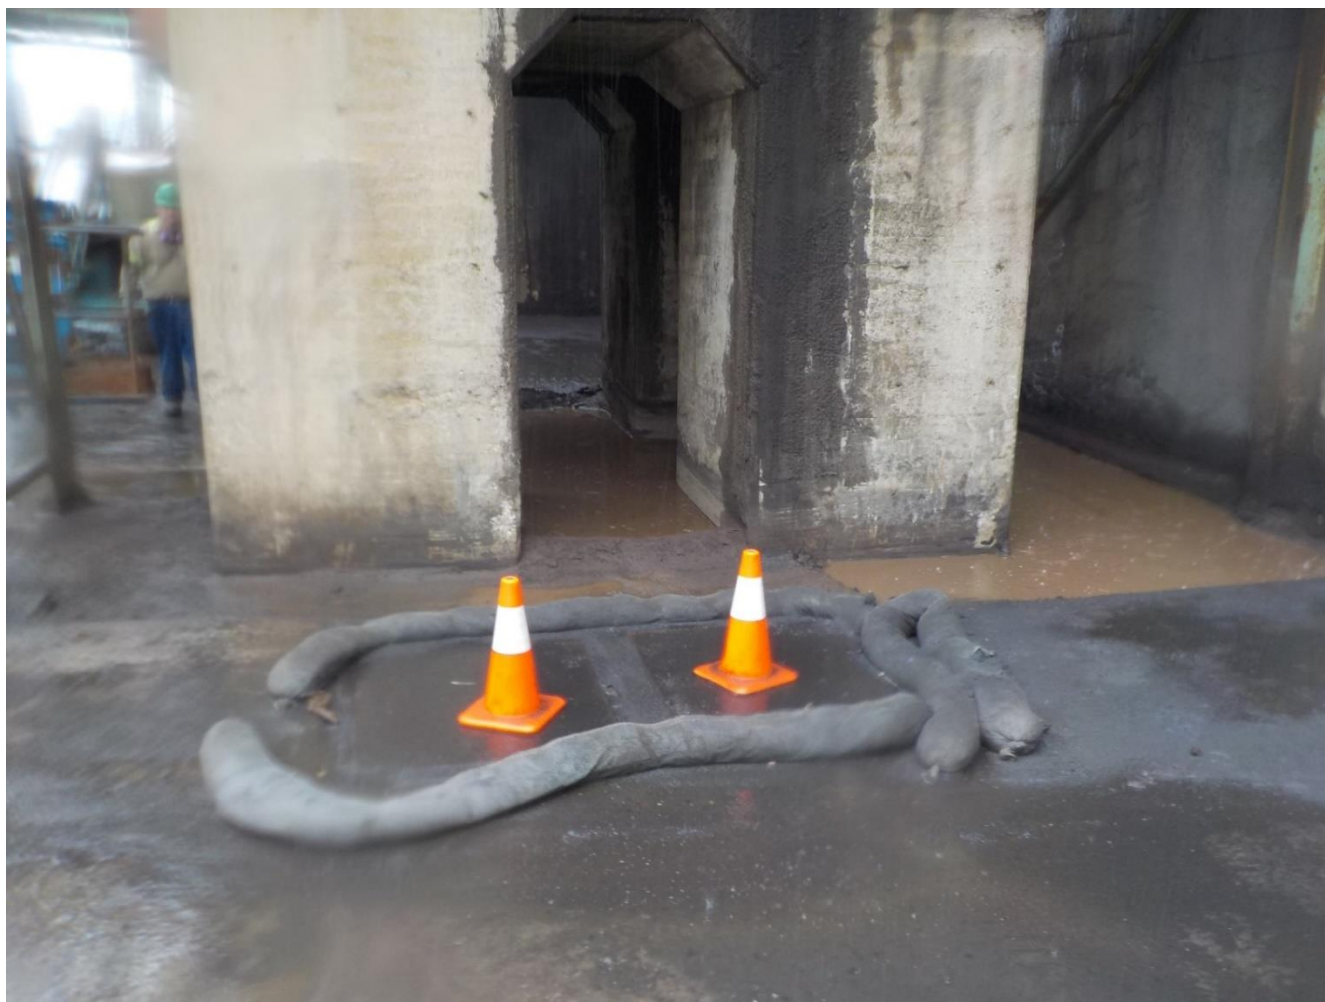
Photo 52. (DSCN0355) This photo, taken during rain on 16 May, 2018, shows catch basin 5, immediately adjacent to the concrete support structure at the lower end of Kiln 2. Note, the pool of brown, co-mingled storm water and quench water runoff that has accumulated below the concrete arches. See also Photo 51 for a comparison with dry weather conditions. See also Photo 53.

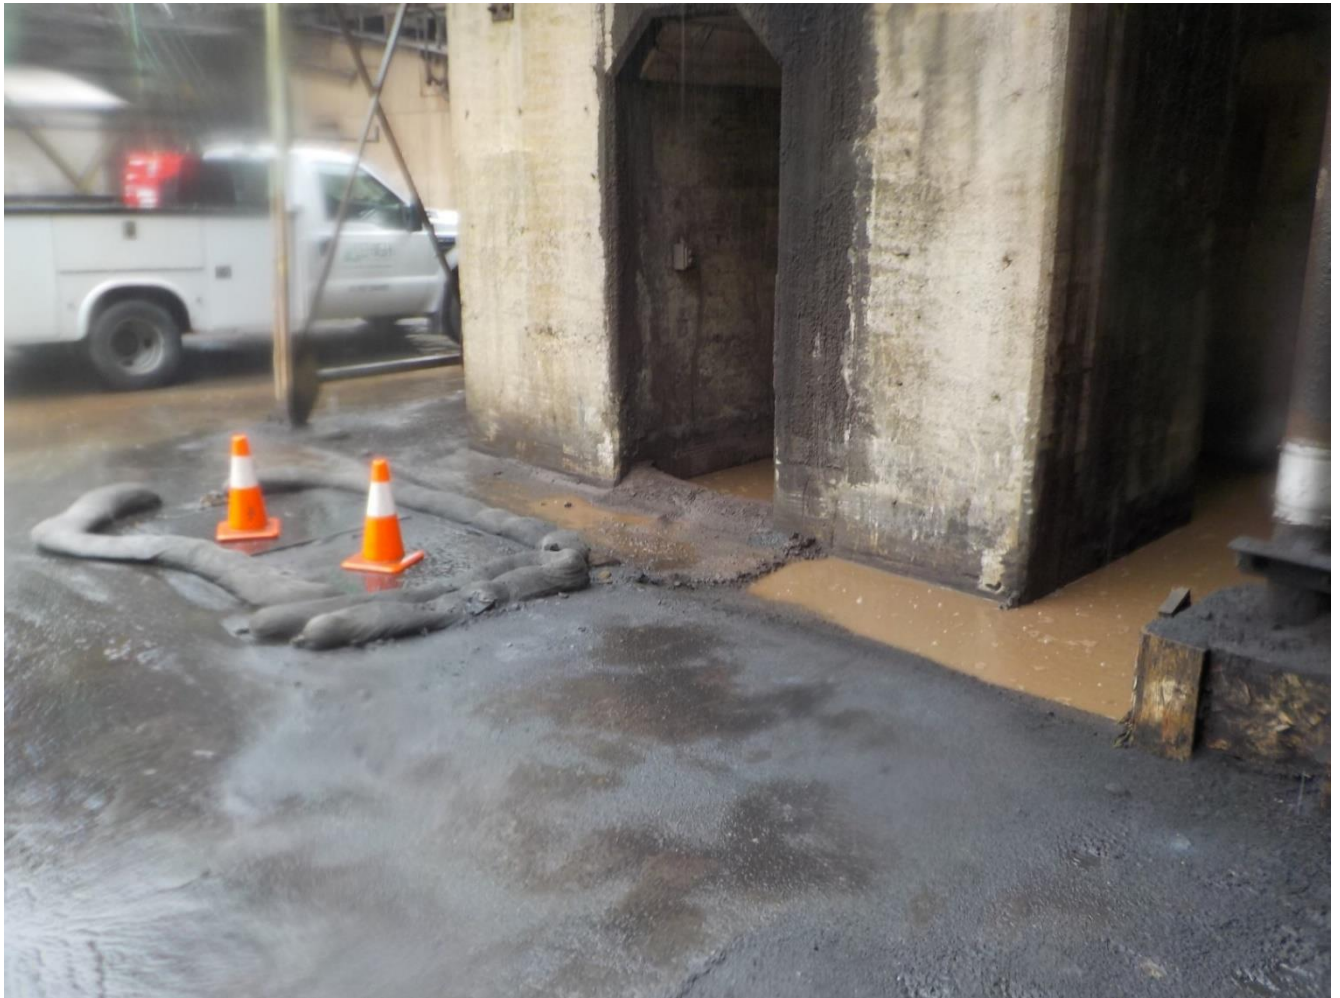
Photo 53. (DSCN0354) This photo, taken during rain on 16 May, 2018, shows another view of catch basin 5, immediately adjacent to the concrete support structure at the lower end of Kiln 2. Note, the pool of brown, co-mingled storm water and quench water runoff that has accumulated below the concrete arches.

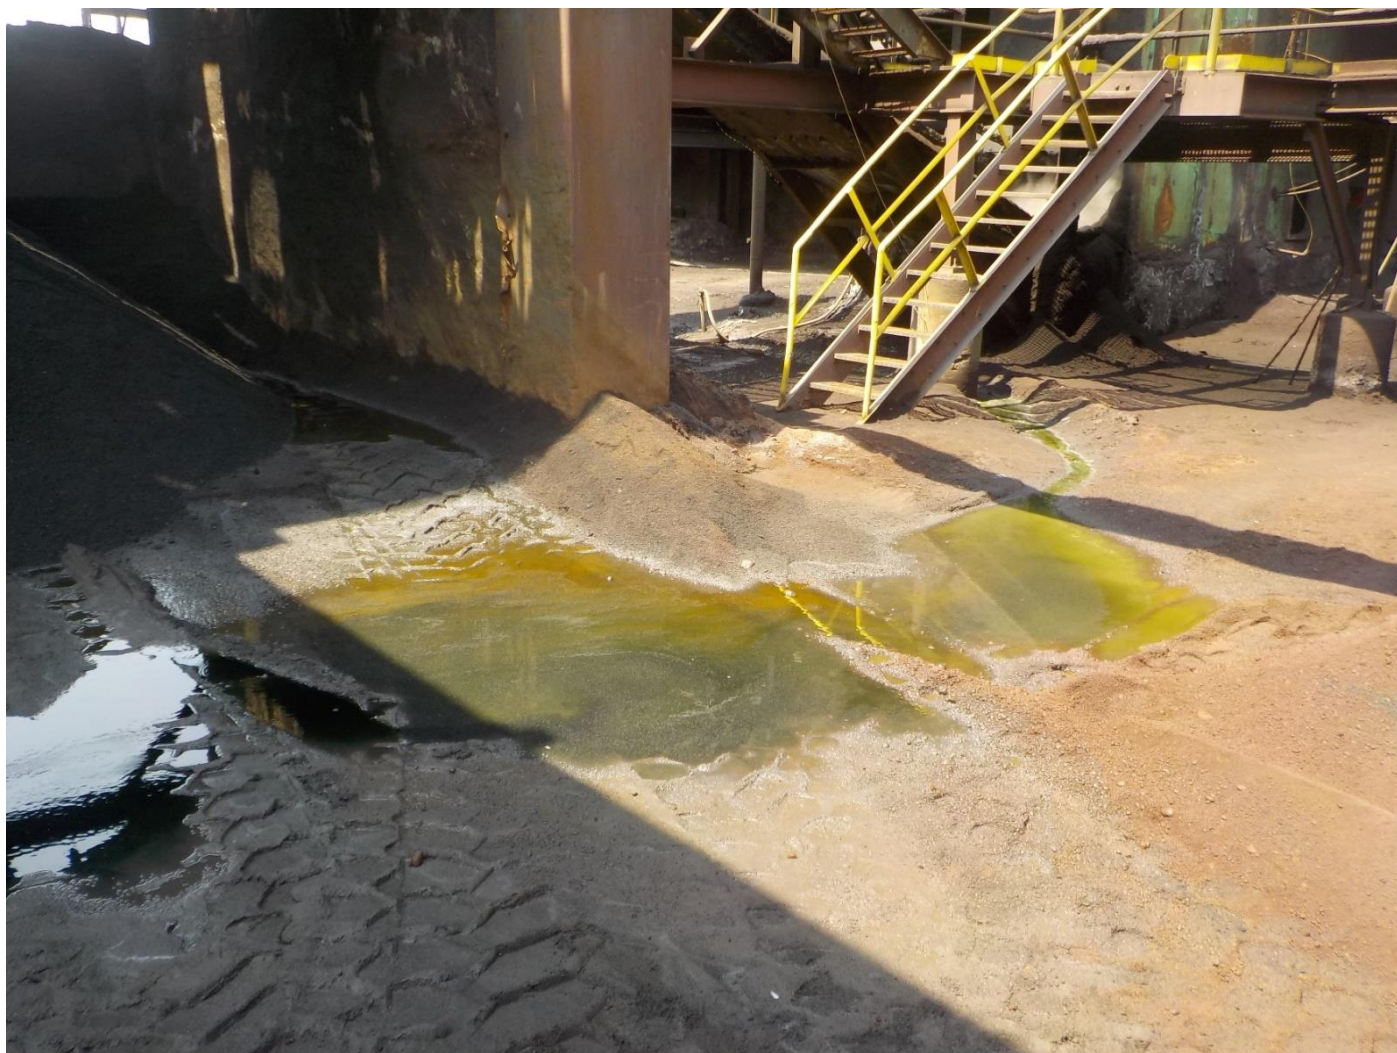
Photo 57. (DSCN0240) This photo, taken from the same location as Photo 56, looks right (northward) from the open end of the IRM bunker for Kiln 2. Note, the dark yellow IRM quench water on the ground pools and drains northward via shallow swale, to the earthen sump shown in Photo 55. The submersible pump and flexible hose that, according to Mr. Falko, returns the quench water to the quench tank, is visible in the background.

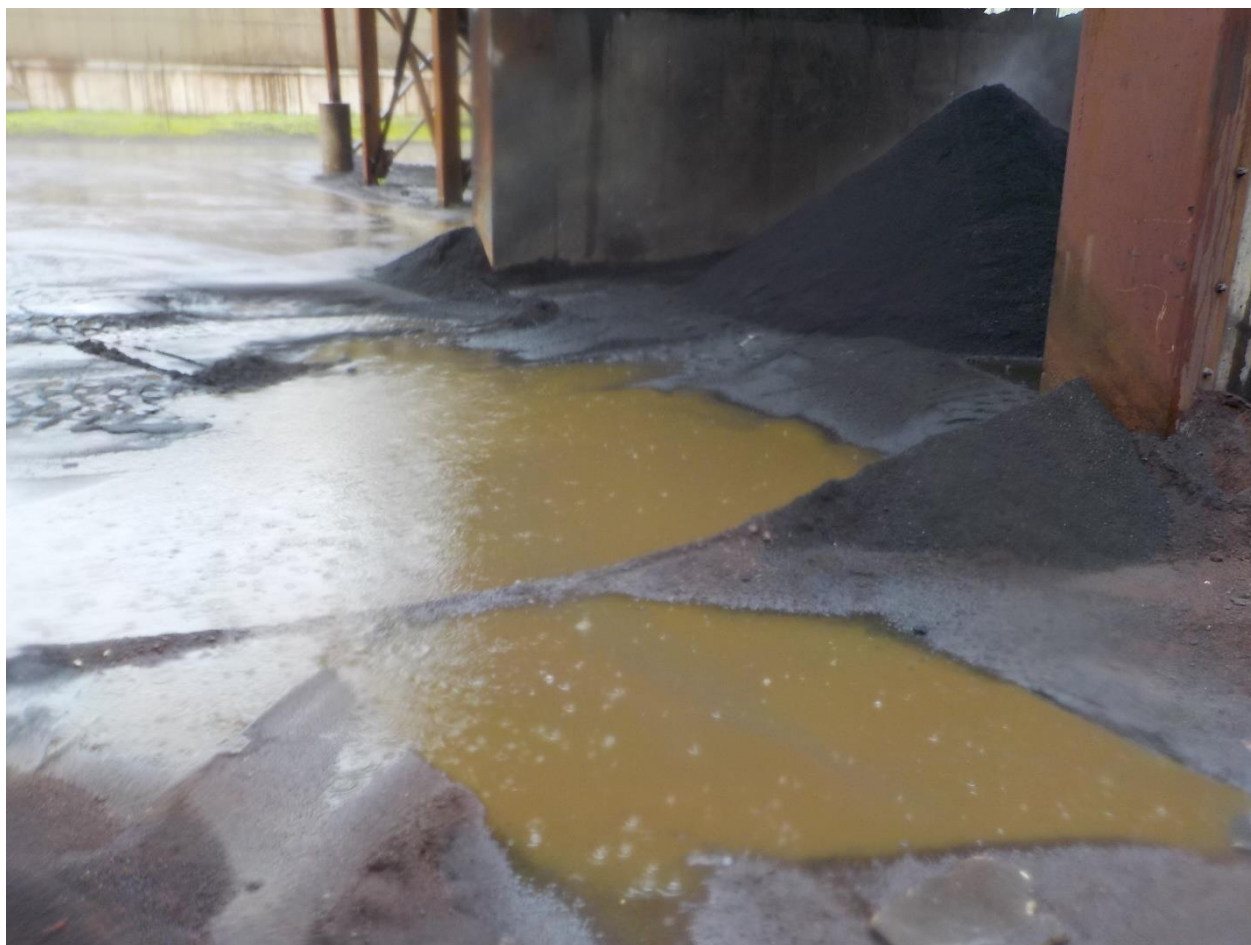
Photo 59. (DSCN0345) This photo, taken during rain on 16 May, 2018, shows the pools of dark yellow IRM quench water in front of the IRM bunker at Kiln 2. See also Photo 56 for comparison to dry weather conditions, and Photo 60.

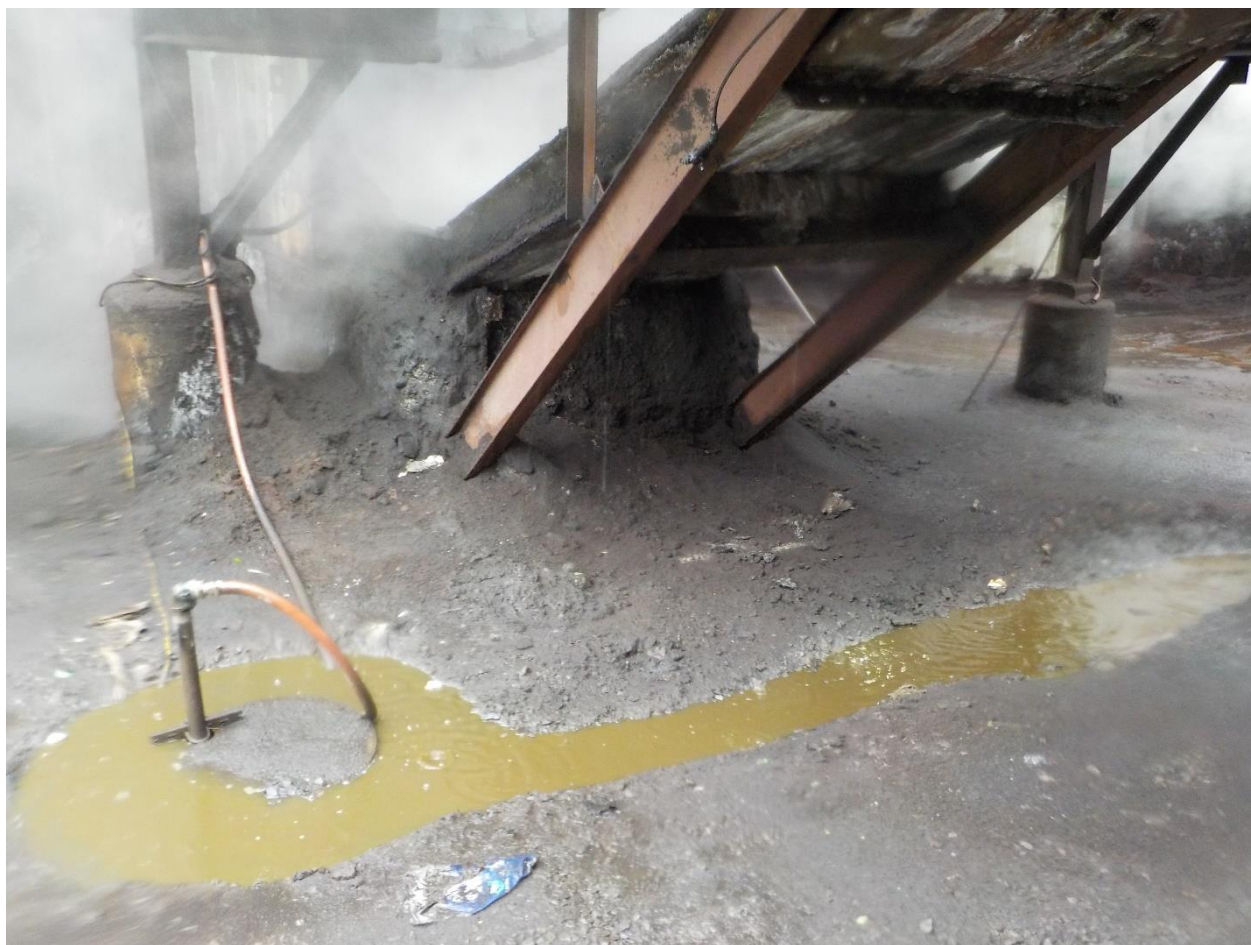
Photo 60. (DSCN0341) This photo, taken during rain on 16 May, 2018, shows dark yellow IRM quench water in the shallow swale and sump near the Kiln 2 quench bath. See also Photo 54 or Photo 55 for comparison to dry weather conditions. See also Photo 59.

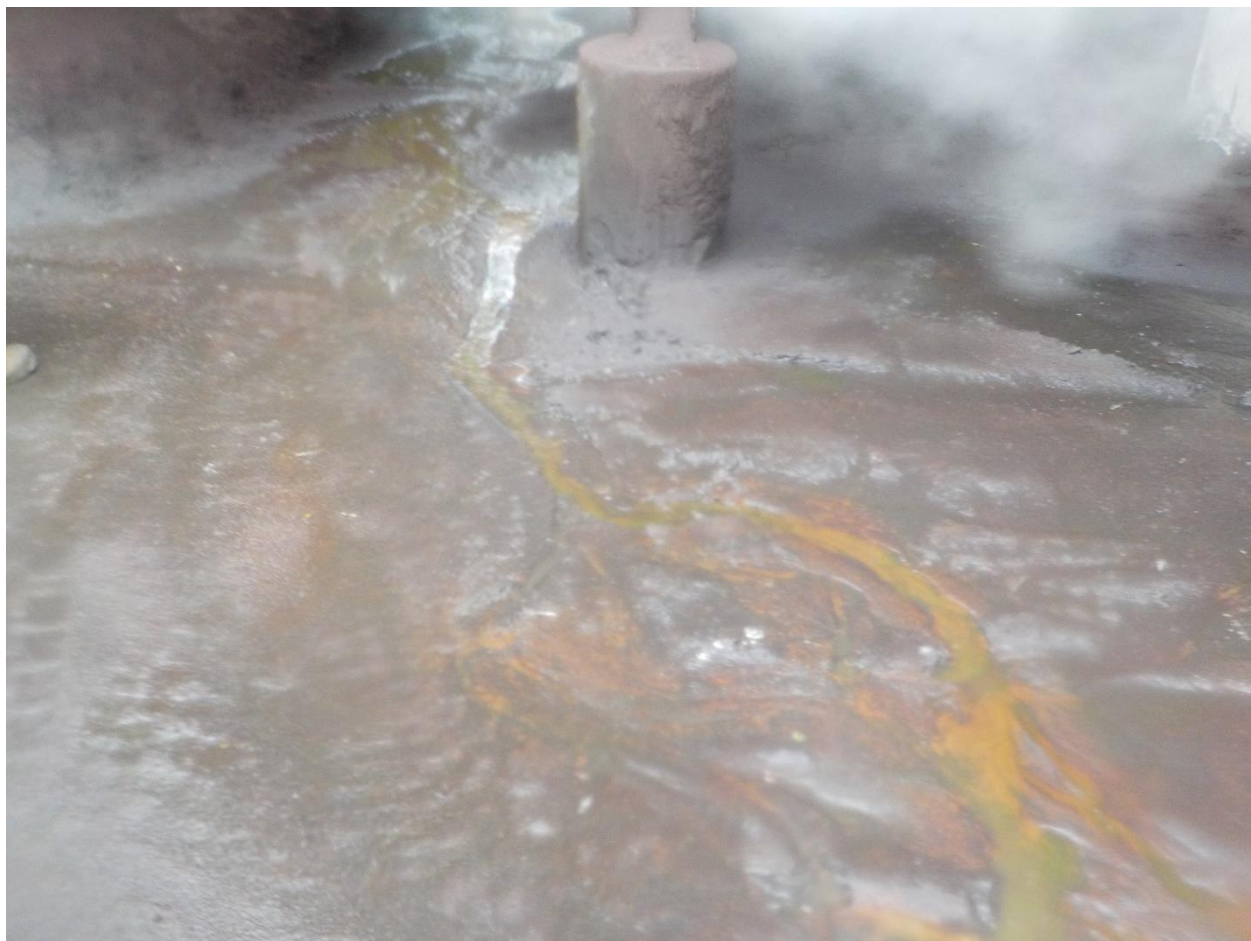
Photo 67. (DSCN0347) This photo is the second in the series of photos (Photos 66-72 inclusive) tracing the northward drainage of reddish-yellow water observed on the ground between Kilns 1 and 2. See also Photos 68-72 inclusive.

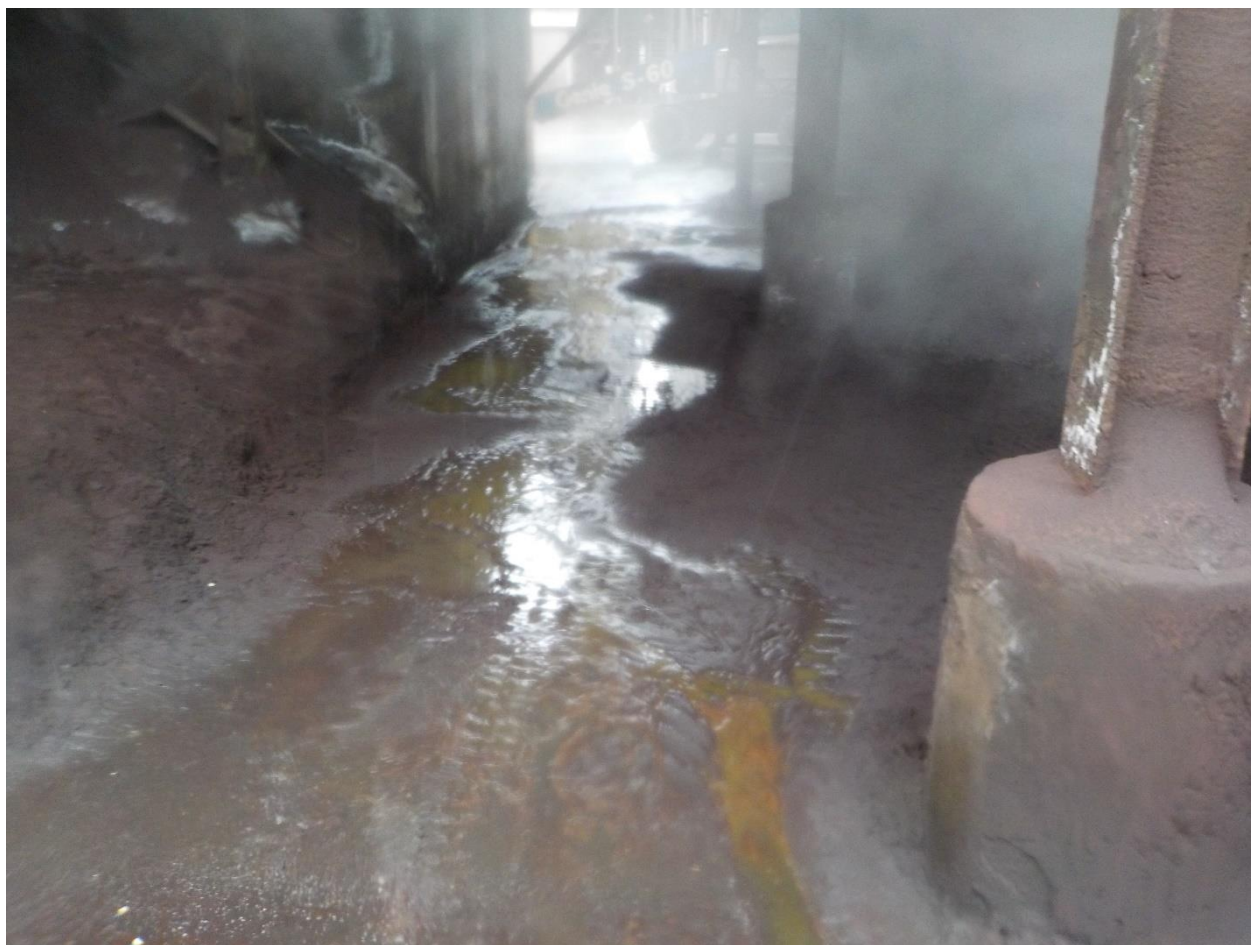
Photo 68. (DSCN0348) This photo is the third in the series of photos (Photos 66-72 inclusive) tracing the northward drainage of reddish-yellow water observed on the ground between Kilns 1 and 2. See also Photos 69-72 inclusive that continue the trace northward.

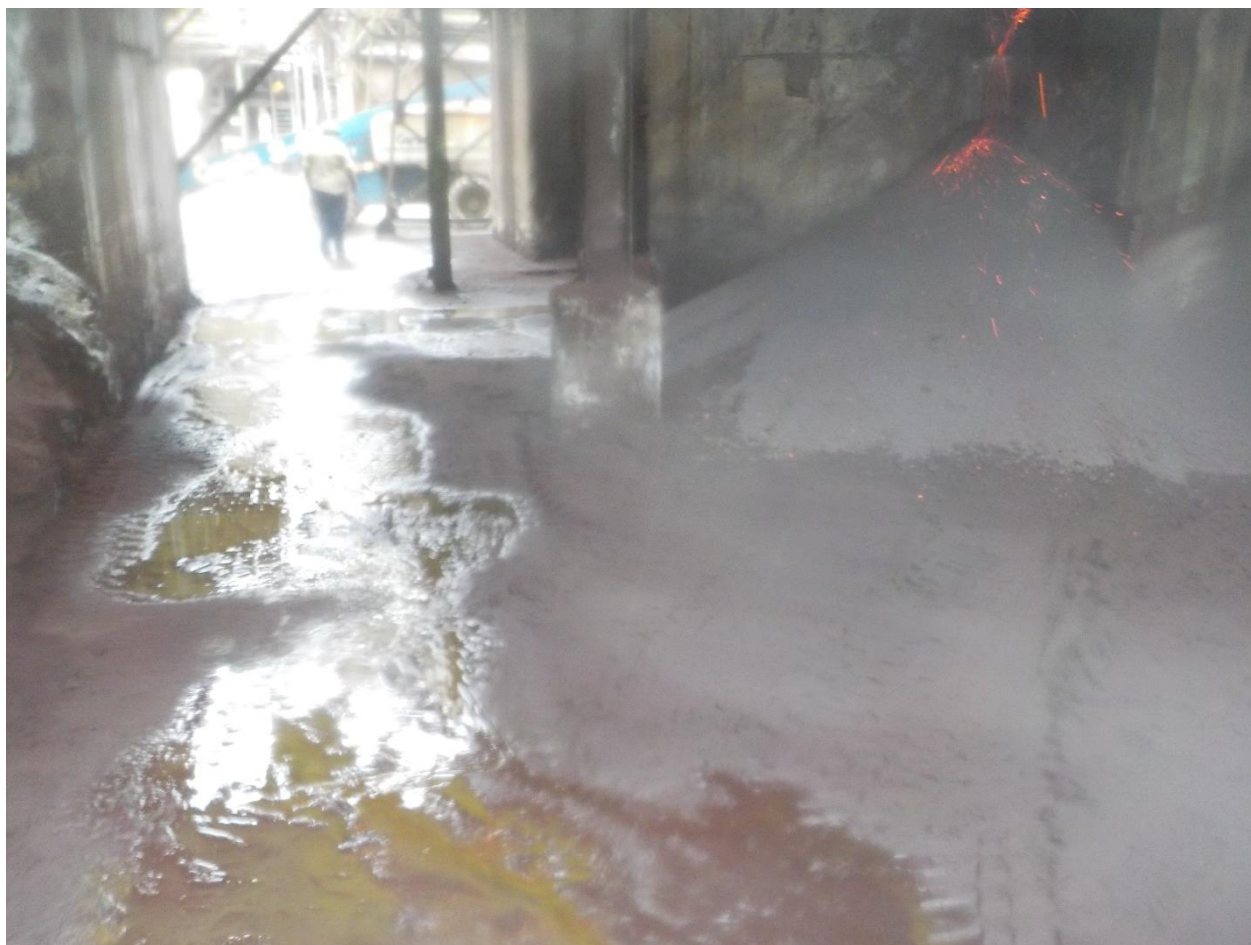
Photo 69. (DSCN0349) This photo is the fourth in the series of photos (Photos 66-72 inclusive) tracing the northward drainage of reddish-yellow water observed on the ground between Kilns 1 and 2. Note a pile of calcine at right, with red-hot calcine dropping onto the pile. See also Photos 70-72 inclusive that continue the trace northward.

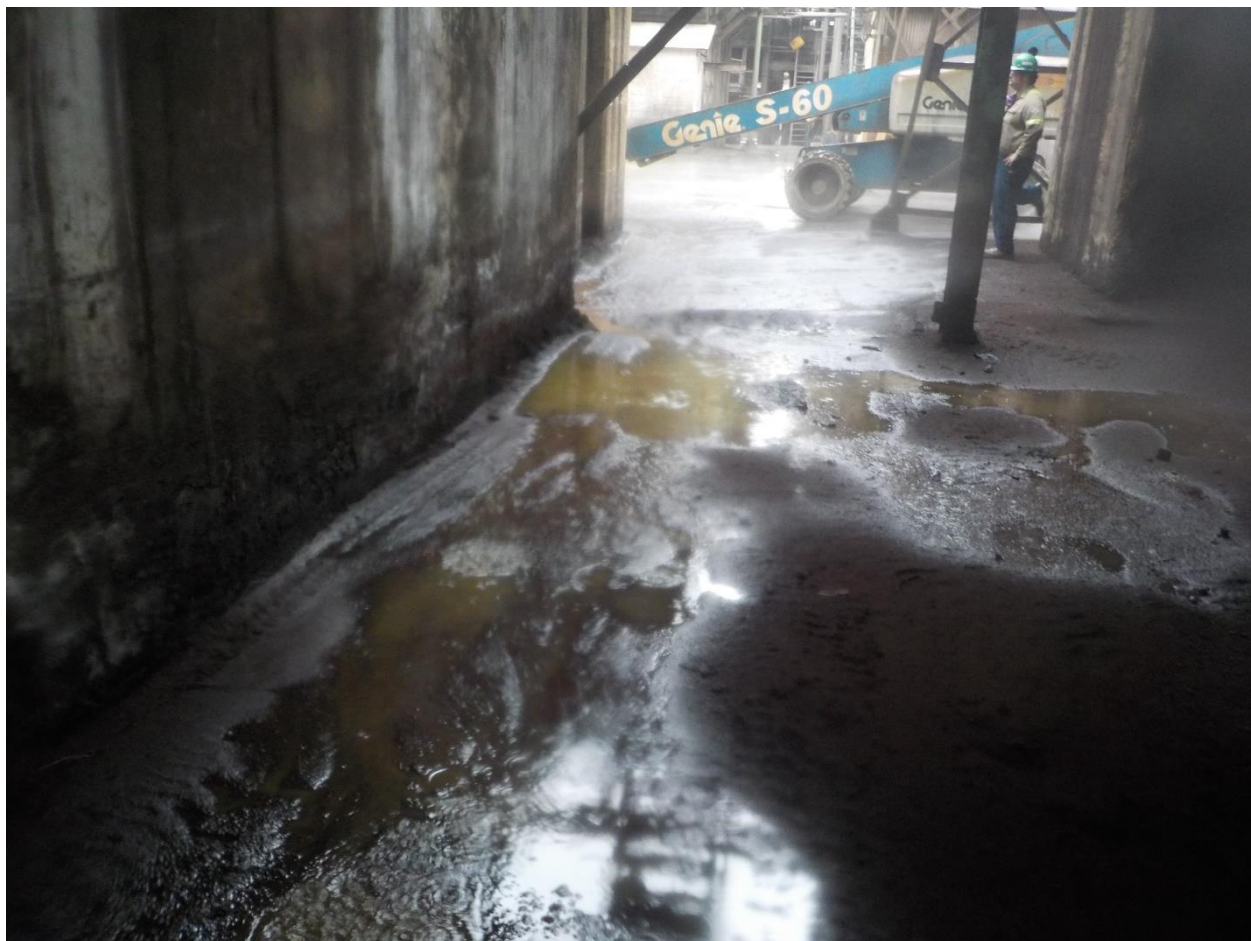
Photo 70. (DSCN0351) This photo is the fifth in the series of photos (Photos 66-72 inclusive) tracing the northward drainage of reddish-yellow water observed on the ground between Kilns 1 and 2. See also Photos 71 and 72 that continue the trace northward.

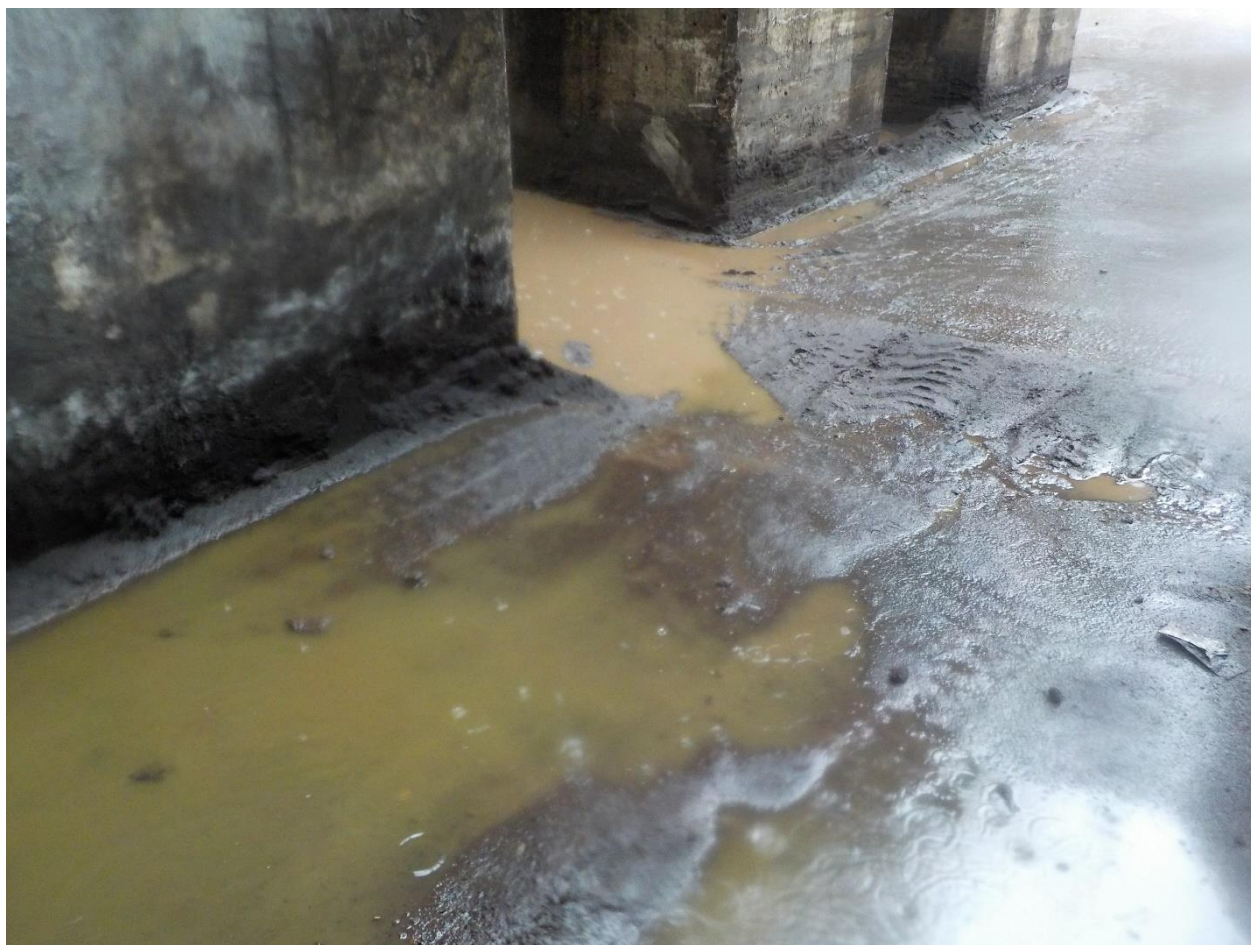
Photo 71. (DSCN0352) This photo is the sixth in the series of photos (Photos 66-72 inclusive) tracing the northward drainage of reddish-yellow water observed on the ground between Kilns 1 and 2. See also Photo 72 that continues the trace northward.

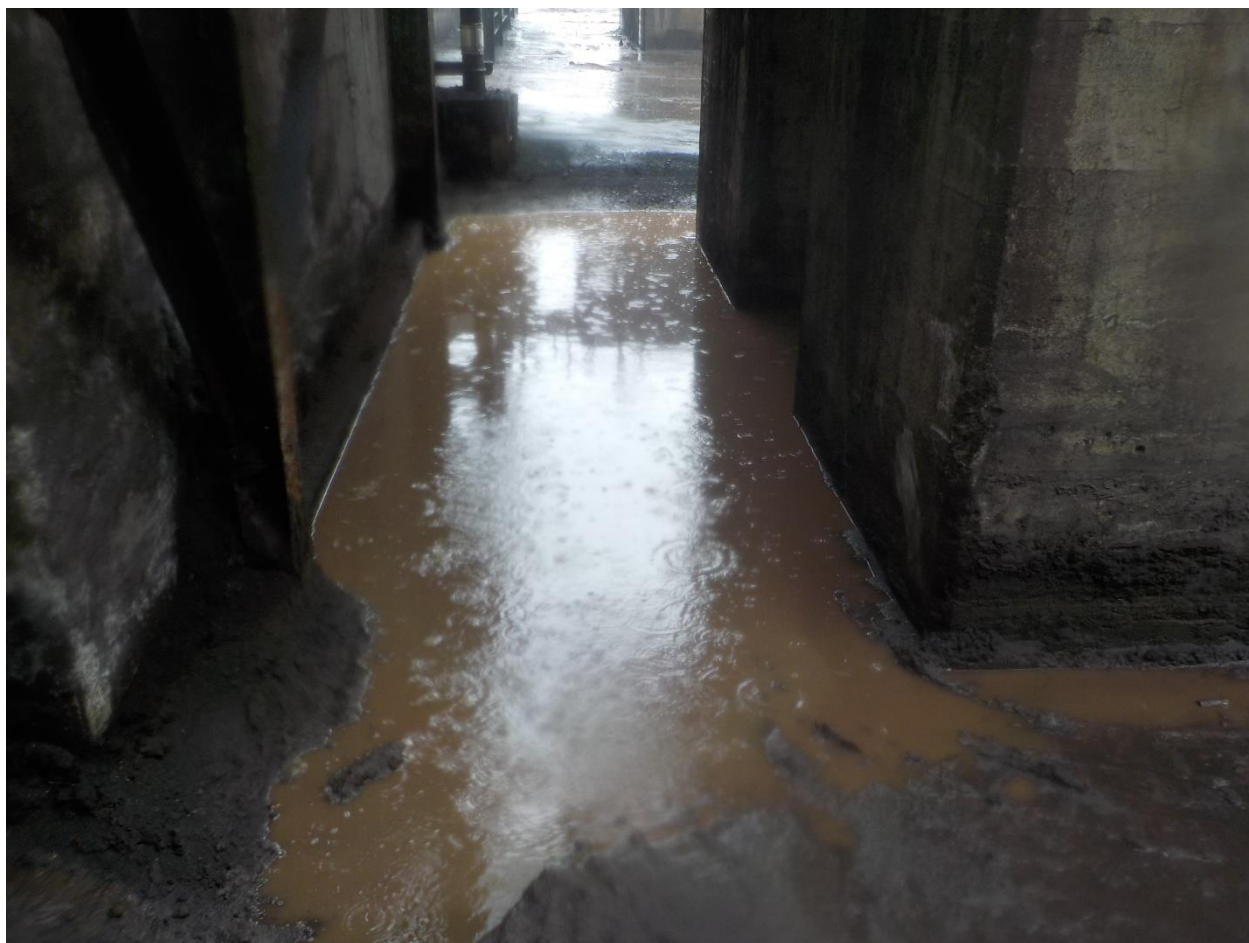
Photo 72. (DSCN0353) This photo is the seventh and last in a series of photos (Photos 66-72) that traces the northward drainage pathway of the reddish-yellow water observed on the ground between Kilns 1 and 2. The pool of yellowish-brown co-mingled storm water and quench water visible in this photo was below the concrete support structure at the lower end of Kiln 2. See also Photos 52 and 53, which show the same pool of water from the western side of the concrete support structure, with respect to the pool's proximity to catch basin 5.
